Home Inspection
for

Inspected By:

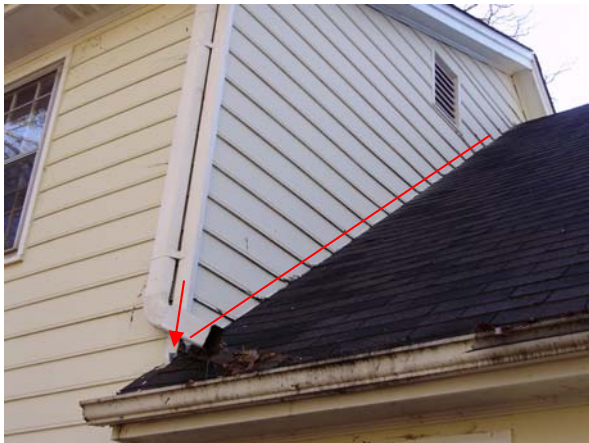
Moisture damage was noted at several pieces of siding along the roofline above the breakfast area in the kitchen and at the bottom of the corner trim above the rear wall of the breakfast area in the kitchen.

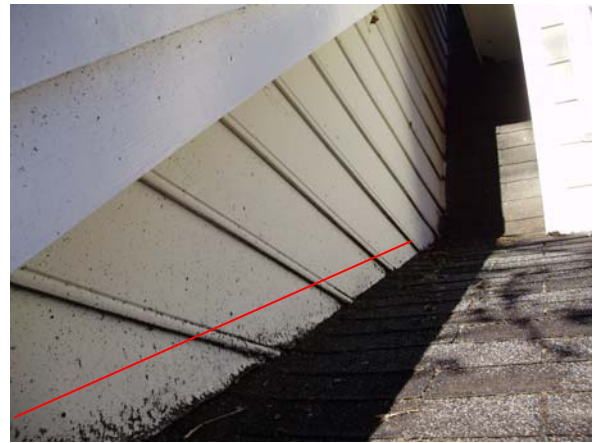
Moisture damage was noted at several pieces of siding along the roofline above the left wall of the front porch.

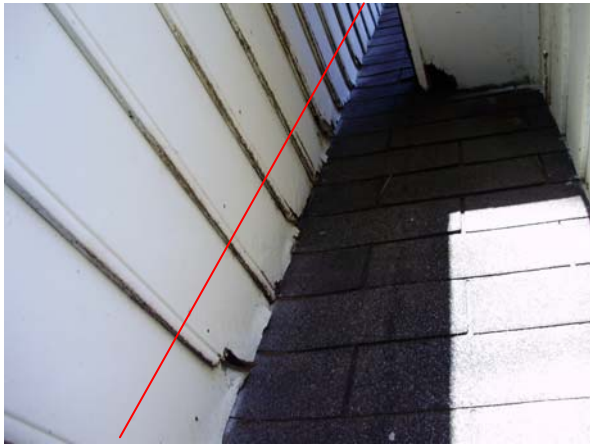
Moisture damage was noted at several pieces of siding along the roofline on the left side of the left dormer on the front of the home.

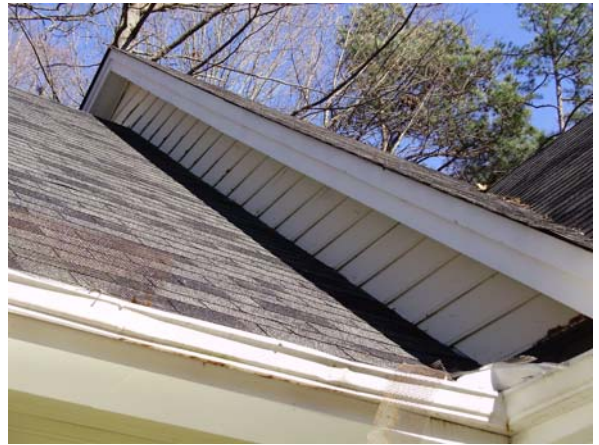
Rodent damage was noted at several pieces of siding along the roofline above the right wall of the garage.

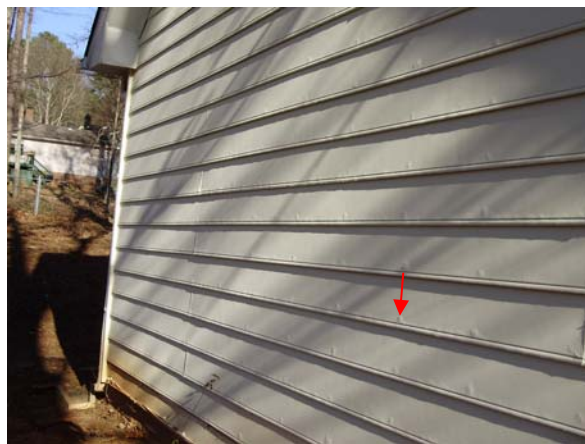
Swelling was present around the nail heads and along the lower edge of various pieces of siding on the left side of the garage.

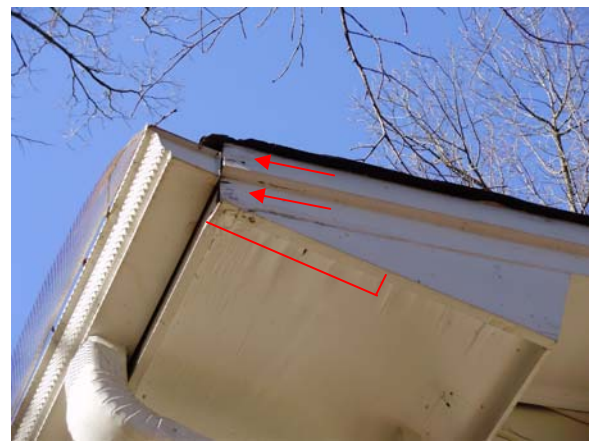
Moisture damage was noted at the fascia/soffit boards behind the gutter at the right corner of the front porch.

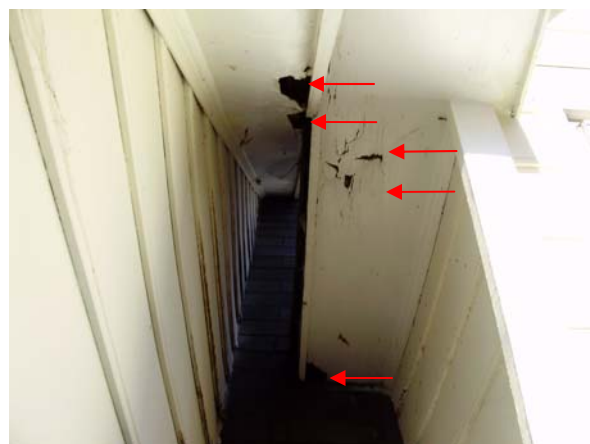
Rodent access holes and moisture damage was noted at the soffit boards on the left side of the left dormer on the front of the home.

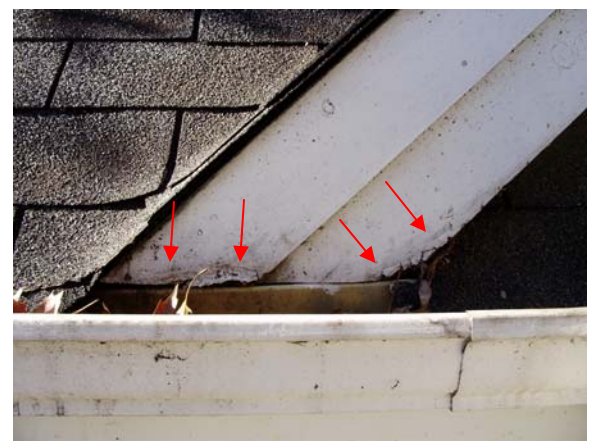
Moisture damage was noted at the fascia boards above the gutter at the bottom of the roof valley above the right wall of the master bedroom.

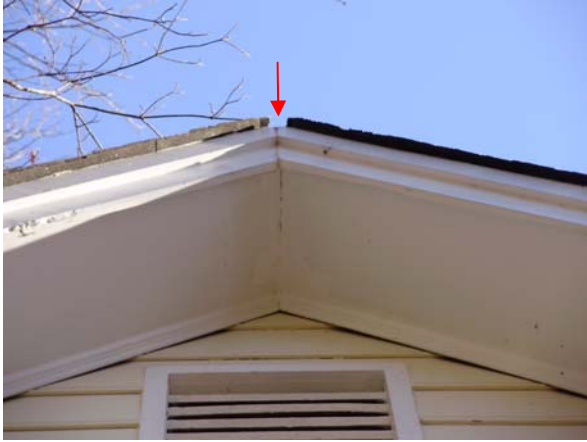
Replace the cracked, outer shingle at the peak of each gable on the home.

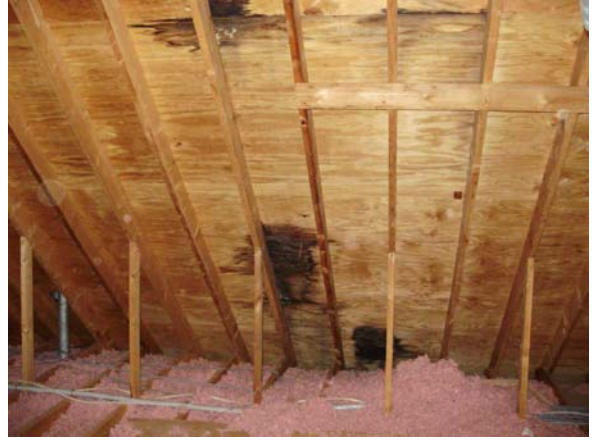
Several stains were present on the plywood roof decking at the rear portion of the attic area above the garage.

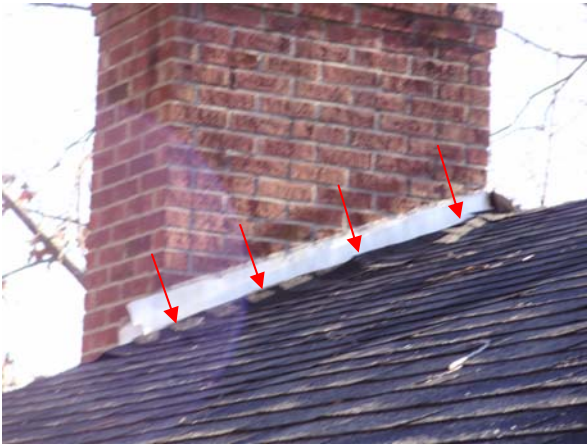
Repair the raised roof flashing along the left side of the chimney chase.

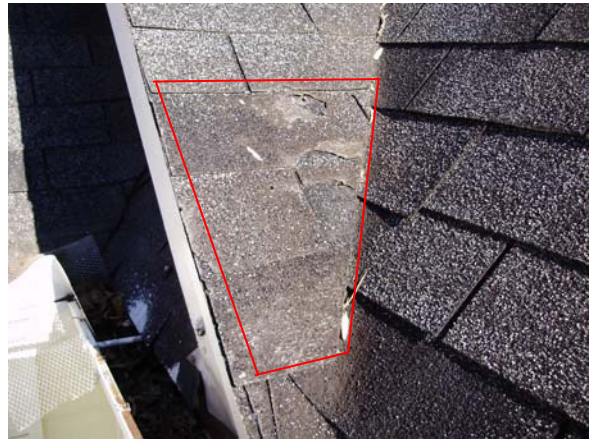
Nail holes and cracks were present in the lower shingles at the bottom of the roof valley above the left wall of the master bathroom.

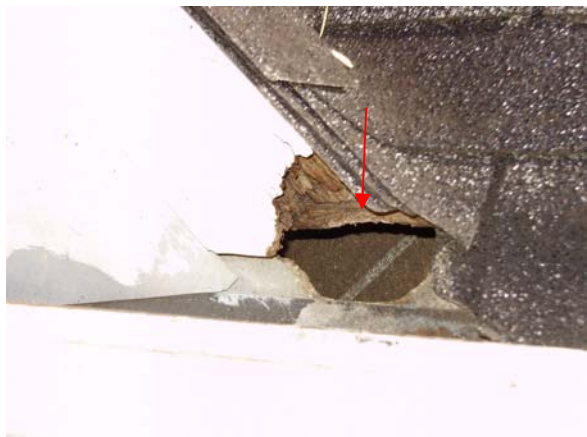
A rodent access hole has been chewed in the fascia boards at the bottom of the roof valley above the left wall of the master bathroom.

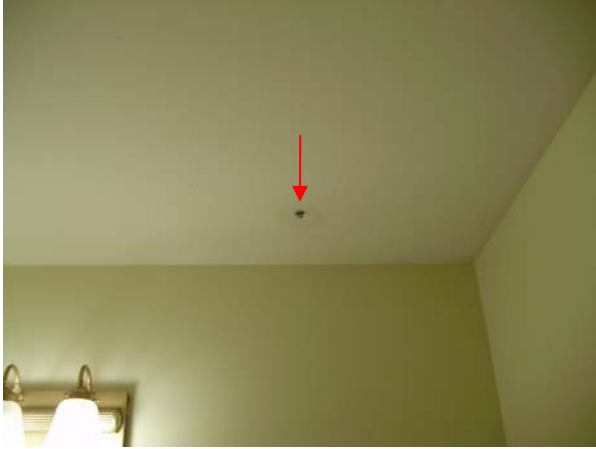
Moisture damage was noted at the sheetrock ceiling above the commode in the half bath, due to an active leak at the commode in the upstairs hall bathroom.

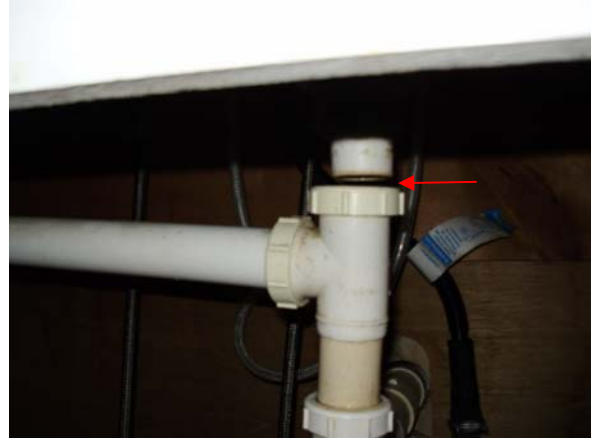
Connect the loose plumbing drainpipe below the right sink in the kitchen.

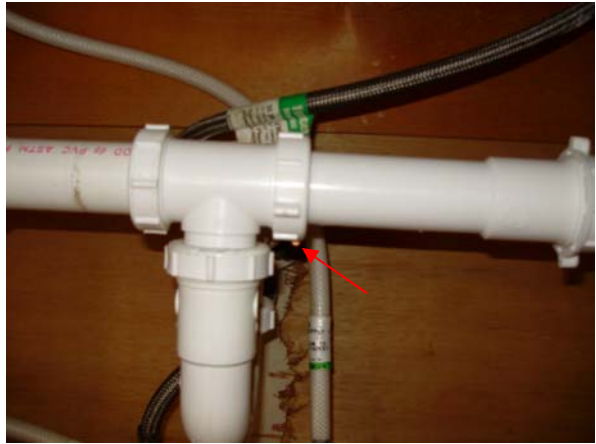
Repair the leak at the union in the plumbing drainpipe below the sinks in the master bathroom.

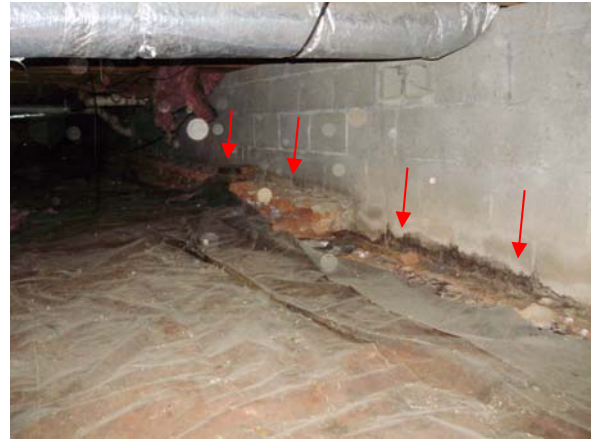
Past moisture stains were present on the lower portion of the rear foundation wall in the crawlspace.

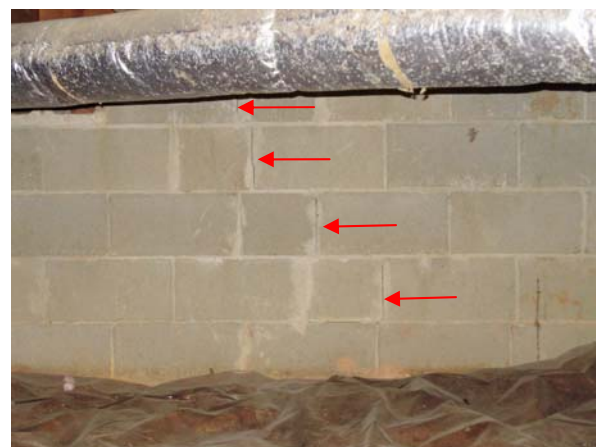
A settling crack present in the concrete block foundation wall below the bay window cavity in the master bedroom (visible in the crawlspace).

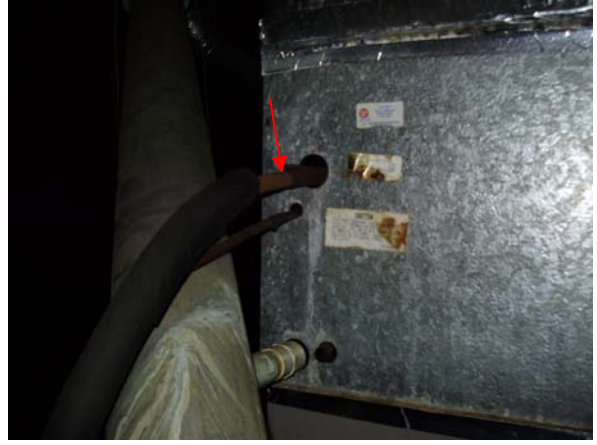
Additional insulation is needed at the voids around the refrigerant return line exiting the a/c evaporator coil in the attic.

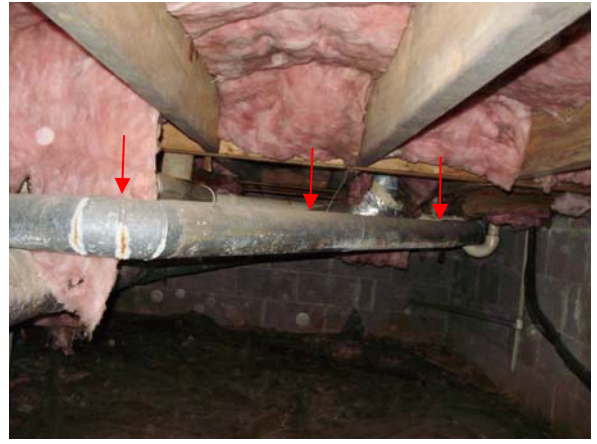
Surface rust was present on the exterior of the main floor furnace flue in the crawlspace.

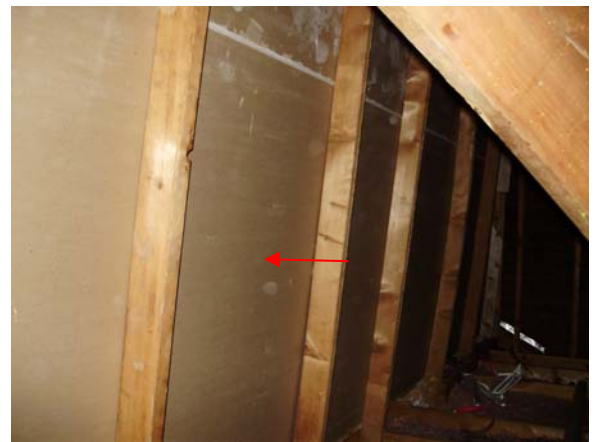
Recommend installing insulation in the left wall of the front, center room in the upper level of the home.

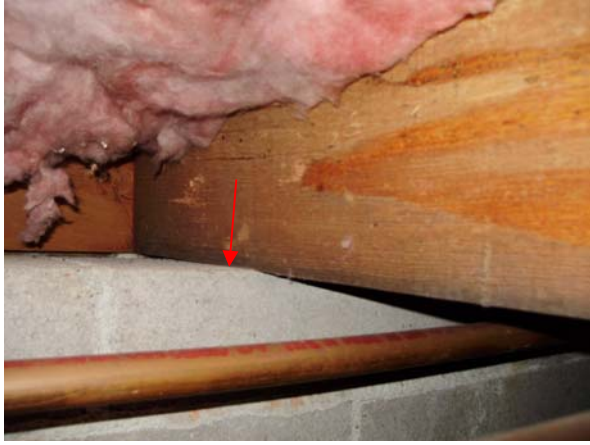
Pressure-treated sill plates were not installed above the foundation walls in the crawlspace.

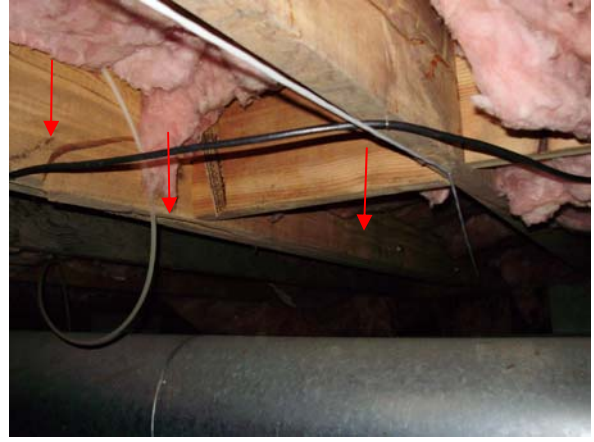
Additional support has been installed at the cracked floor joist below the center portion of the kitchen floor.
